Flight Motor Set 360H005 (STS-28R) Final Report

**Volume V
(Nozzle Component)**

September 1990

***Thiokol* CORPORATION
SPACE OPERATIONS**

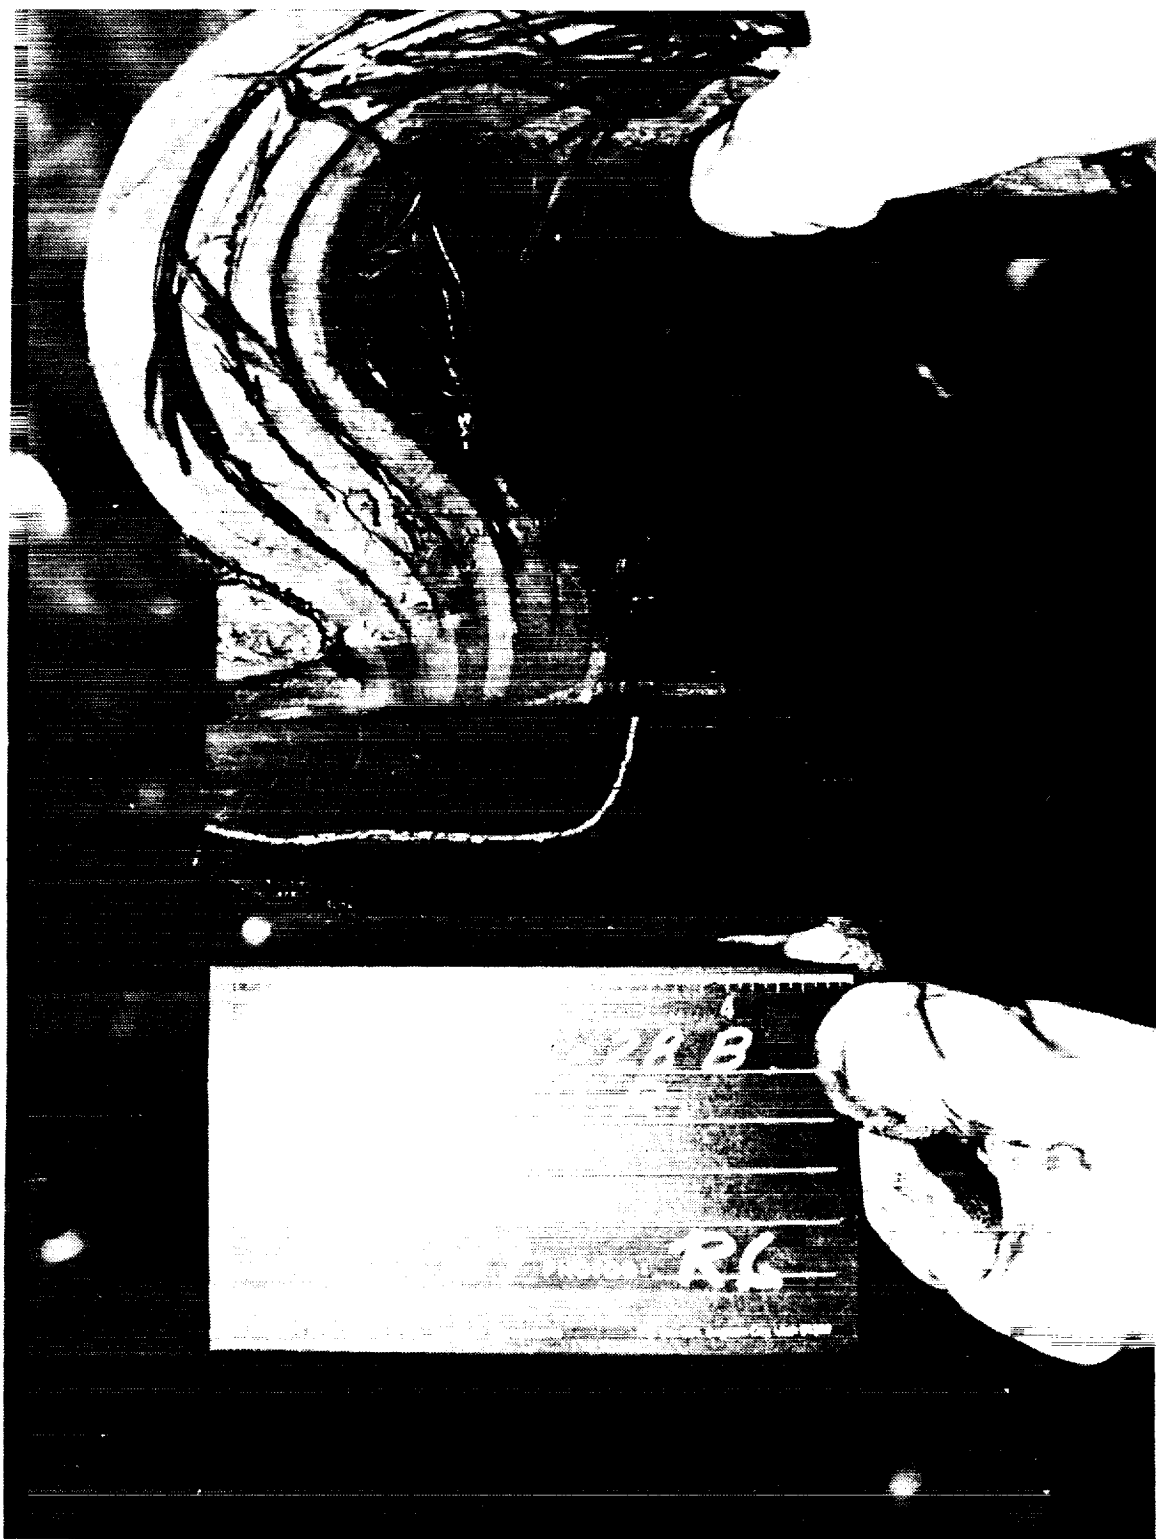
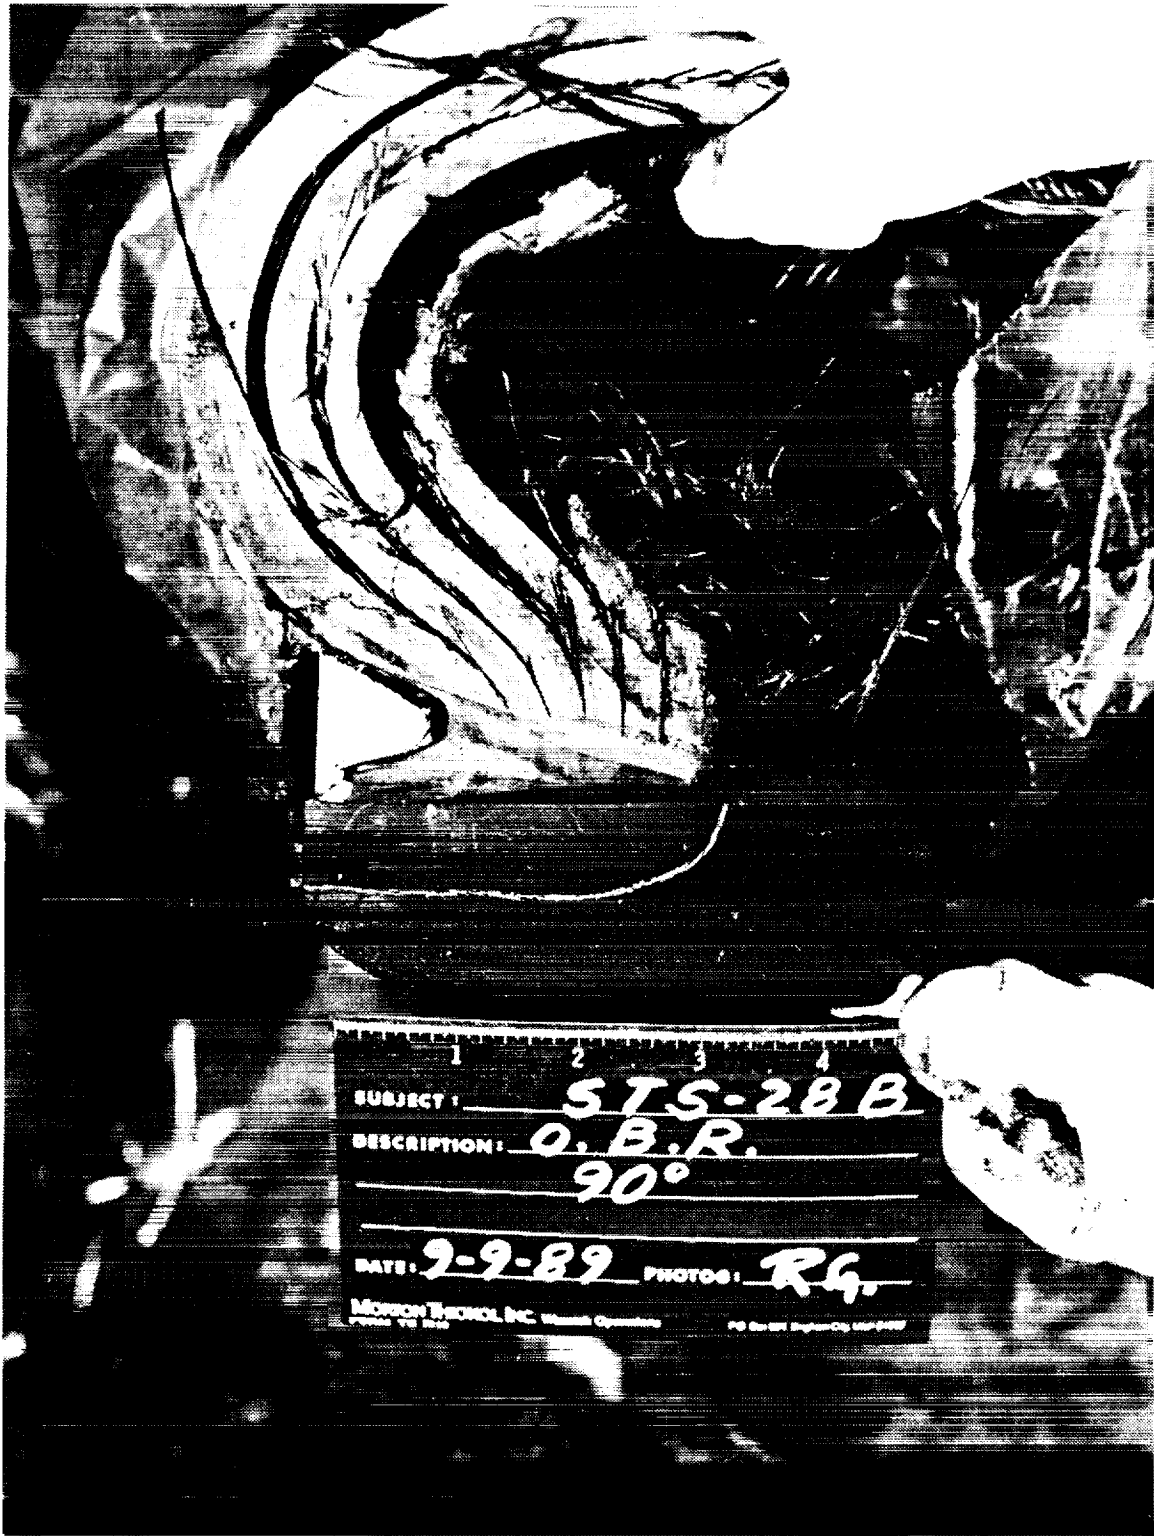
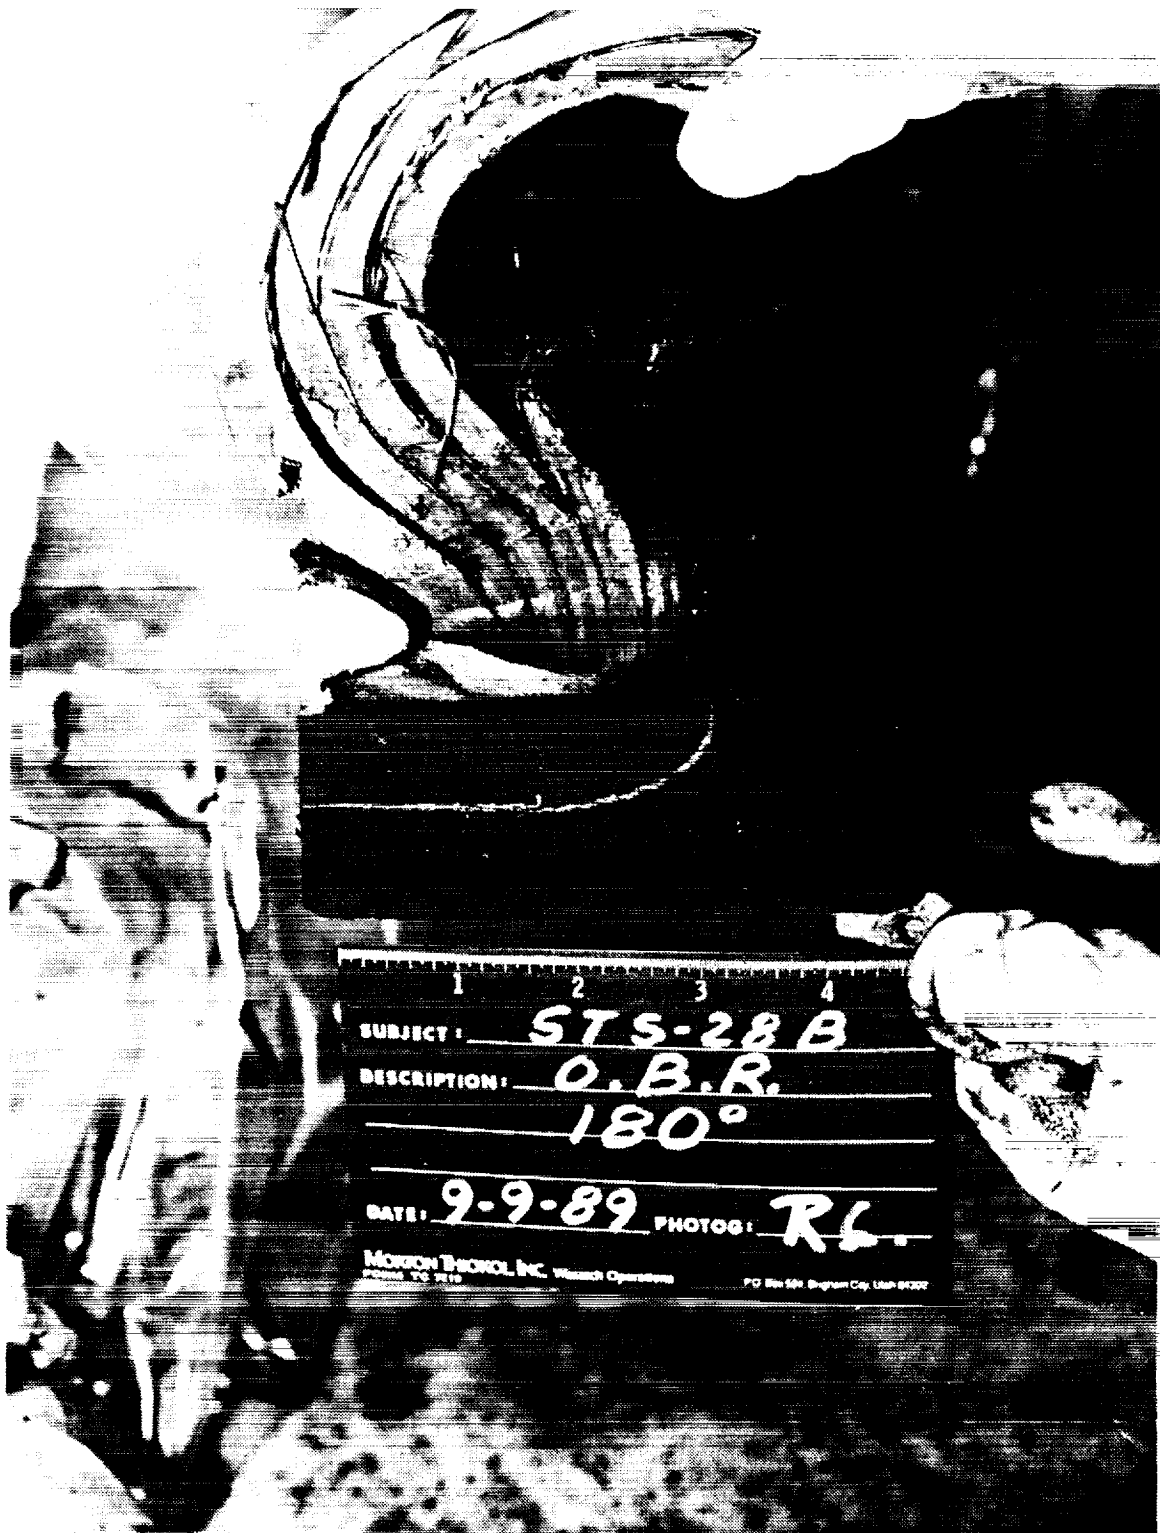
Photographs of the sectioned outer boot ring are presented in Figures 124 through 127. Char and erosion analysis of the sections is presented in Table 14 (Stations 8 through 11.3). All margins of safety were positive, with a minimum of 0.07 occurring at station 9 (90 degrees).

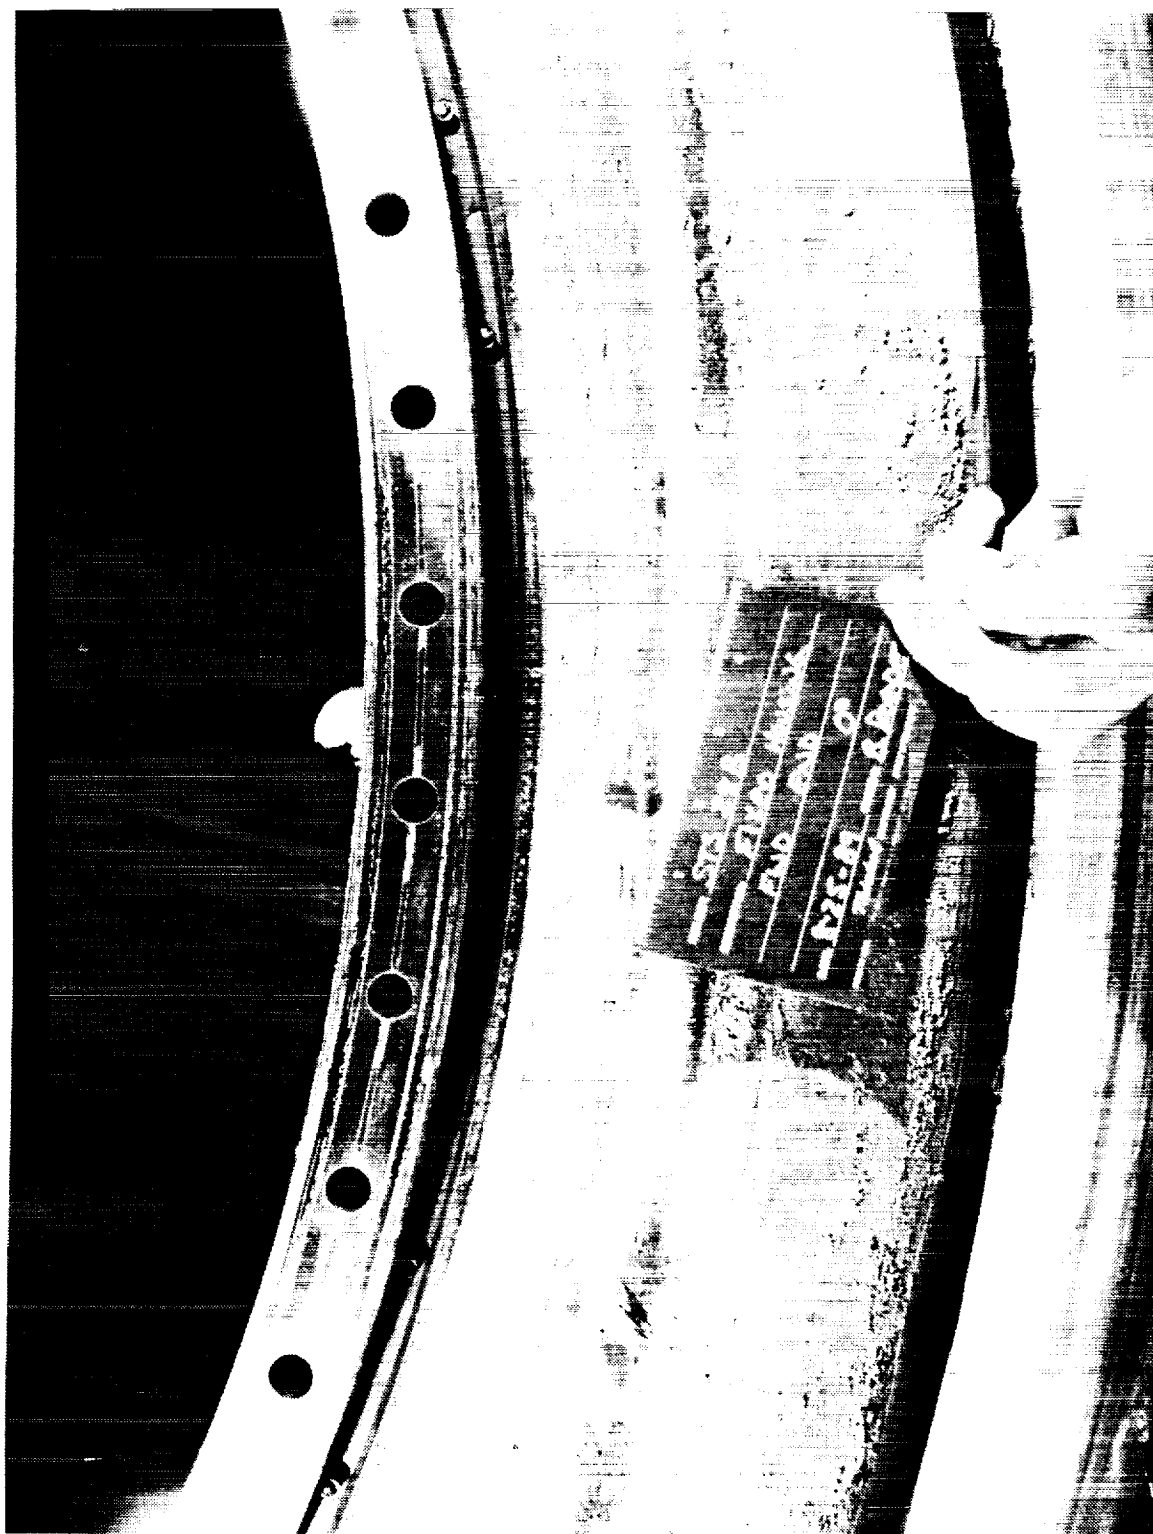
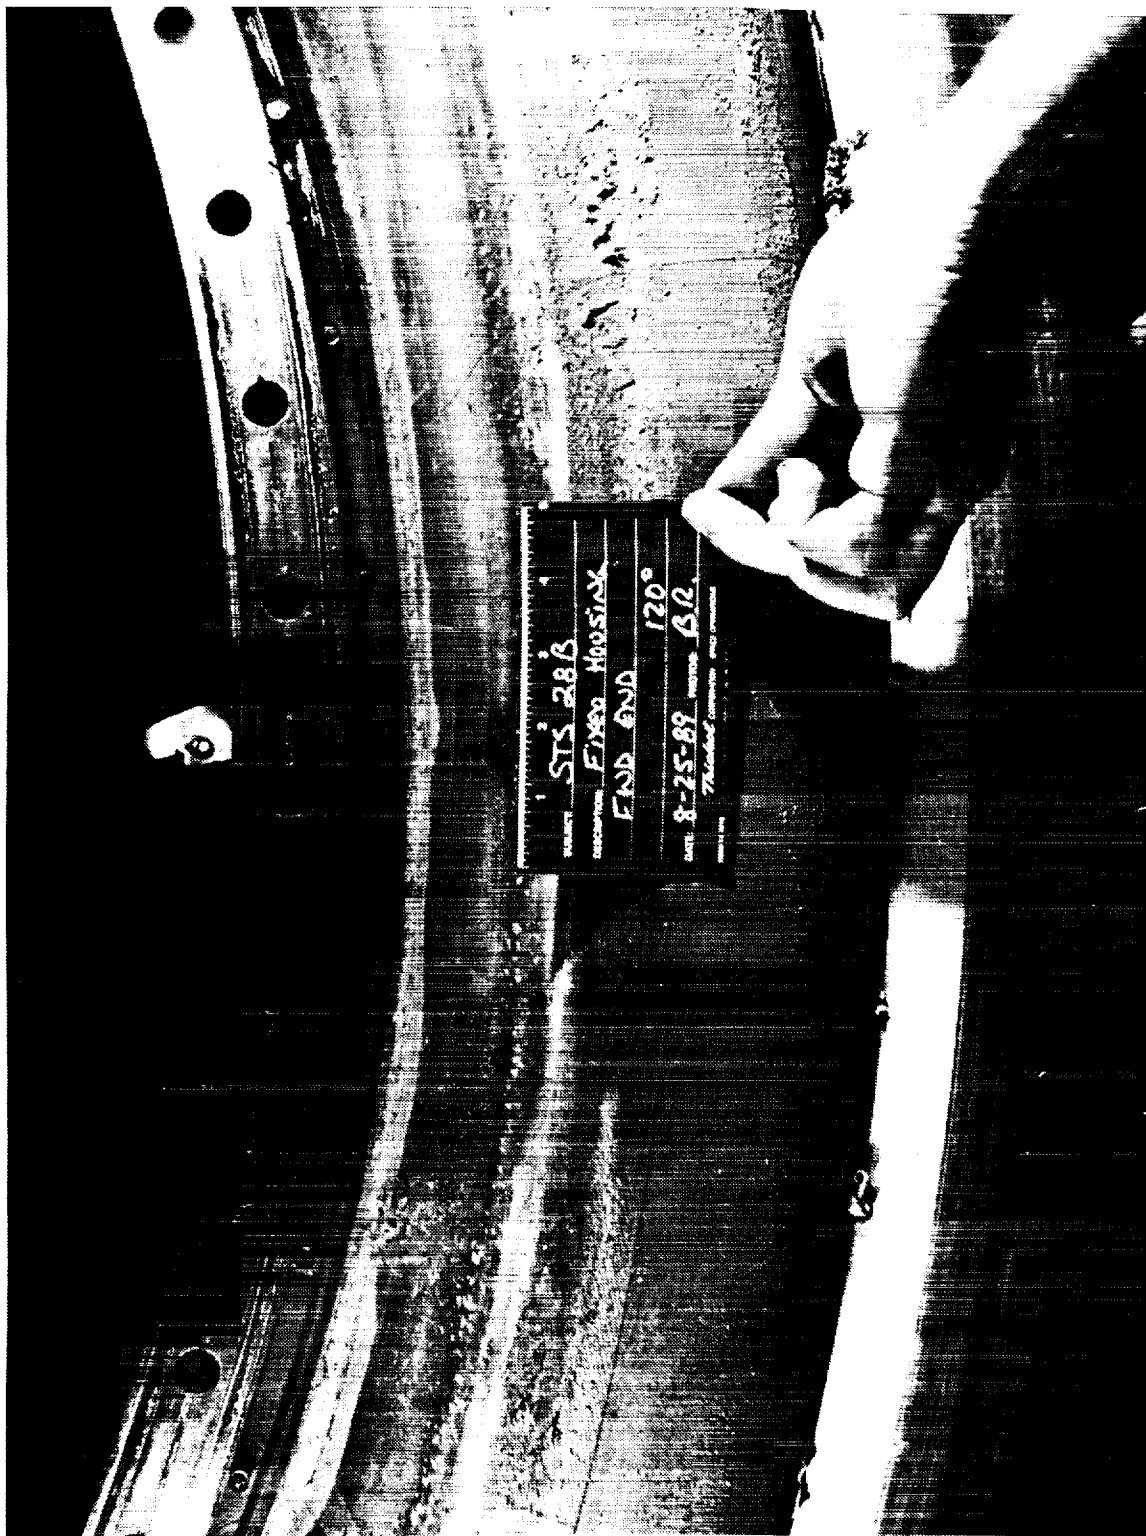
The cavity side of the flex boot was evenly sooted and showed no evidence of flow or erosion (Figures 128 through 130). It appeared typical of previous flight and static test motor flex boots. A minimum of 3.25 NBR plies remained around the circumference after motor burn. Table 15 presents the flex boot material affected depths and Performance Margins of Safety. The worst-case PMS was 0.26 at 270 degrees.

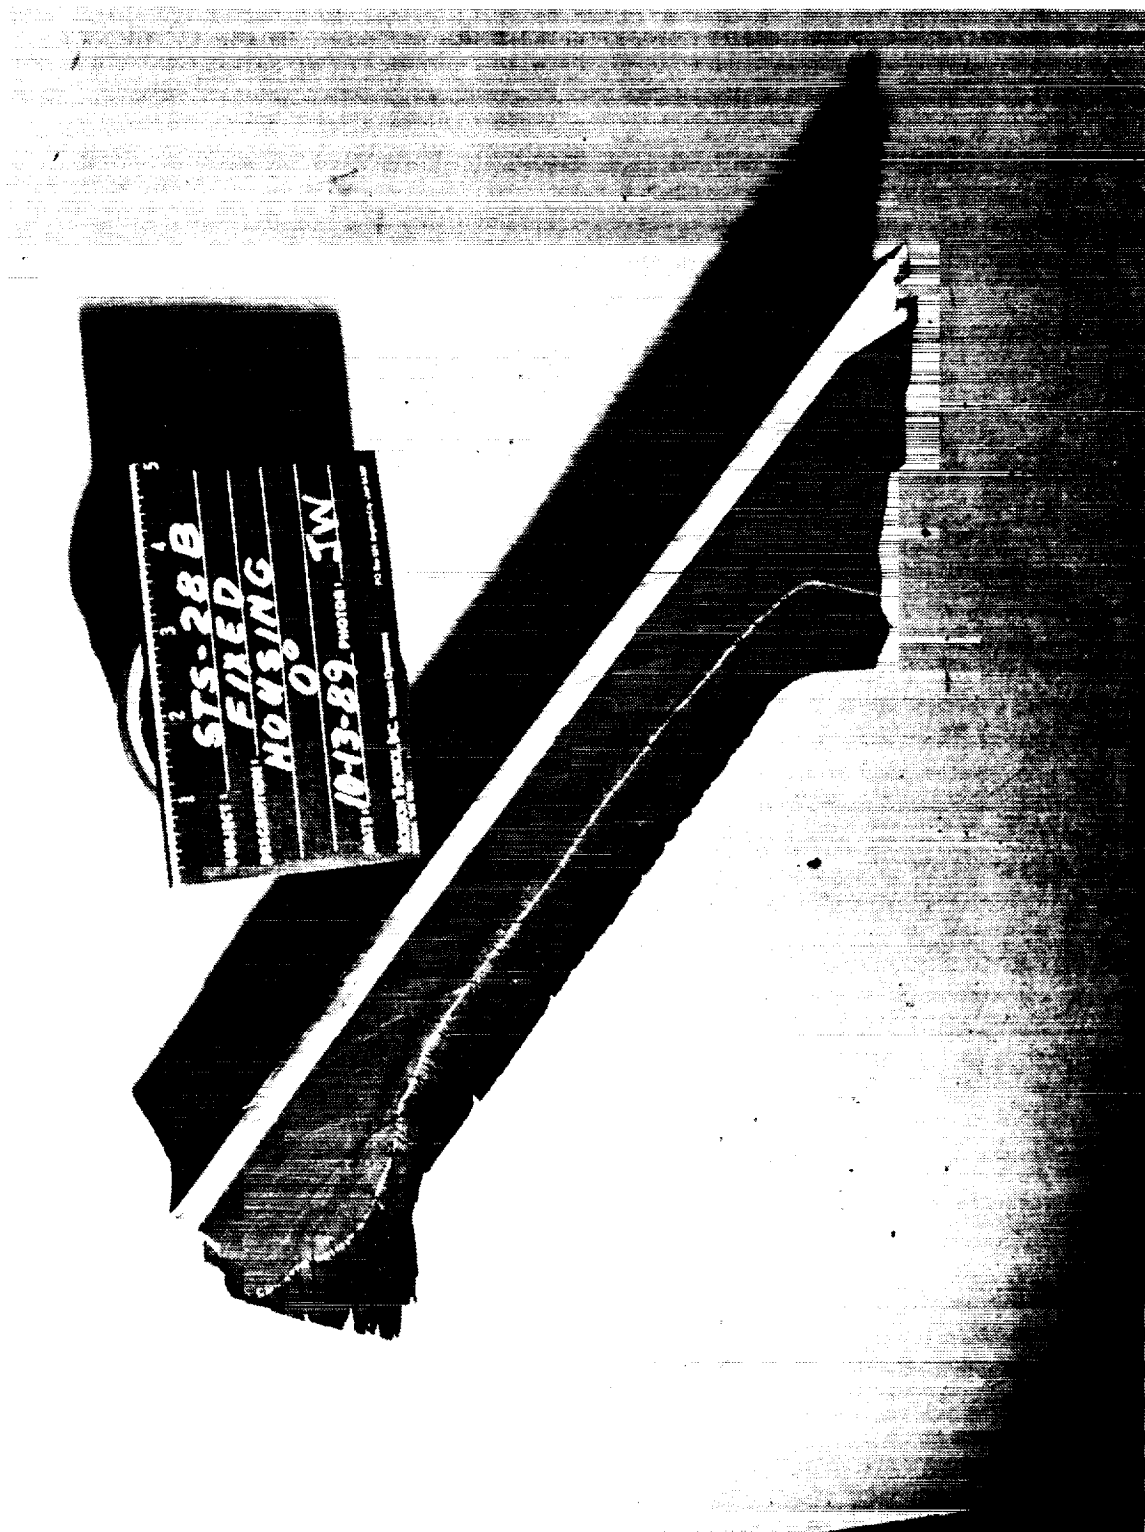
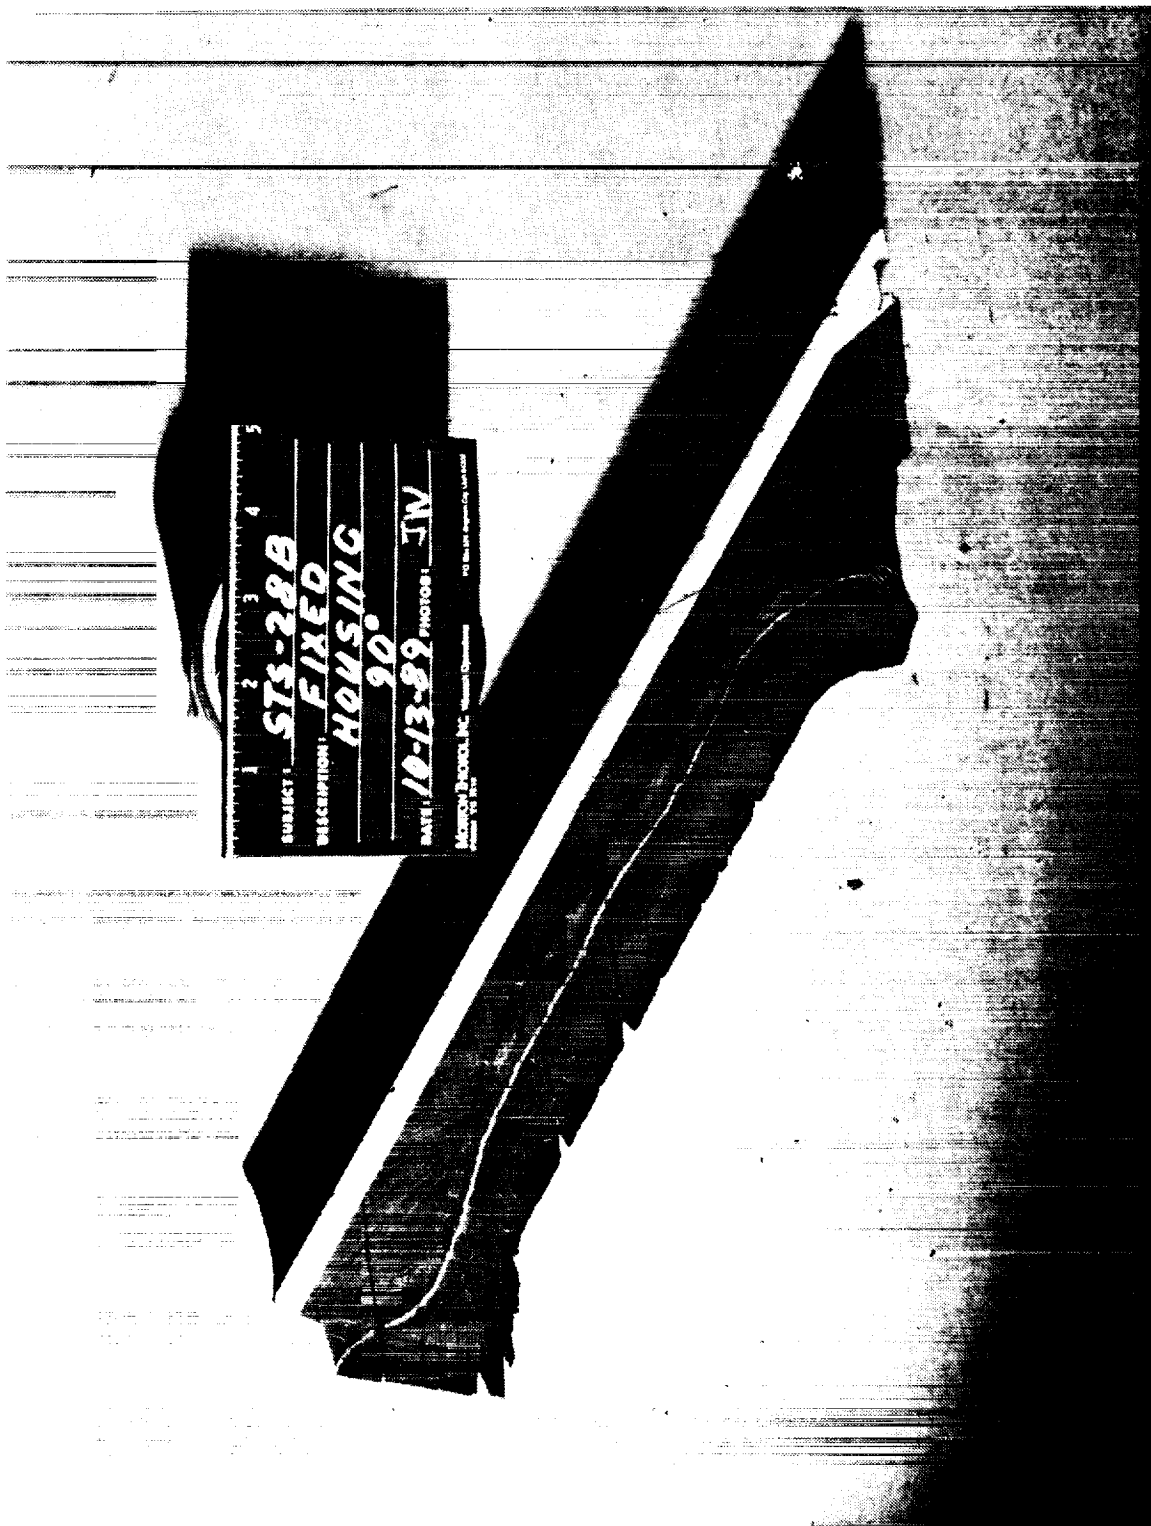
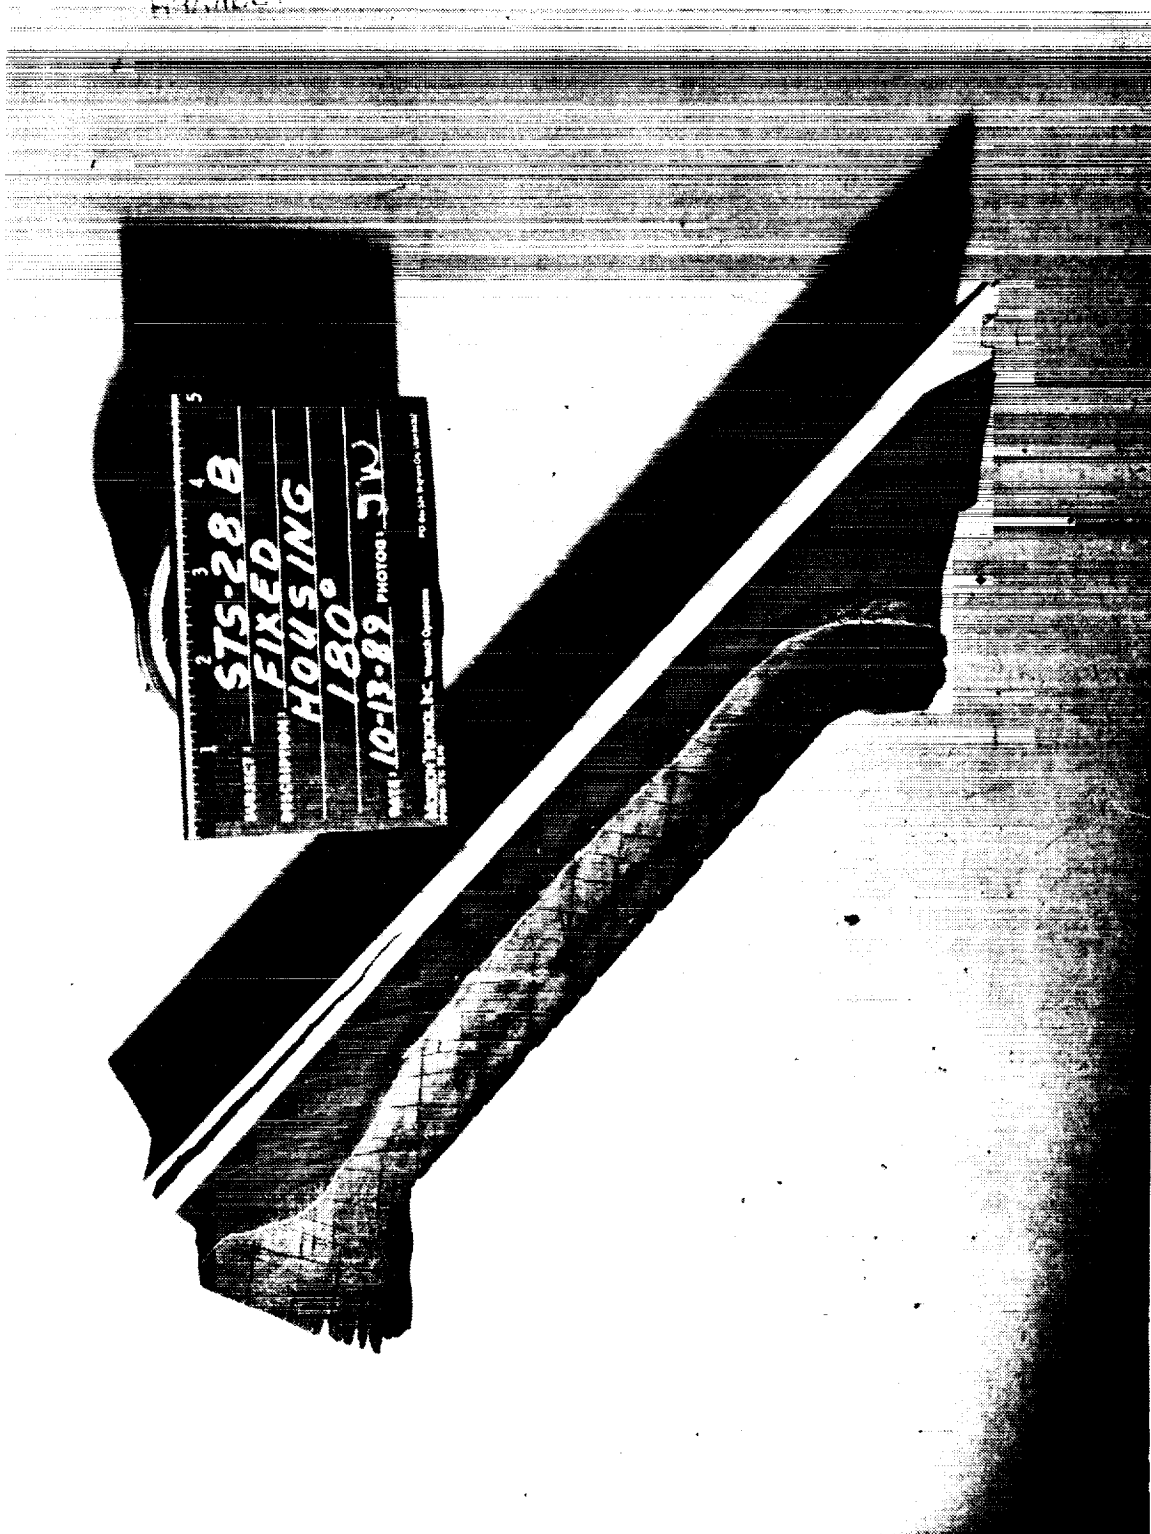
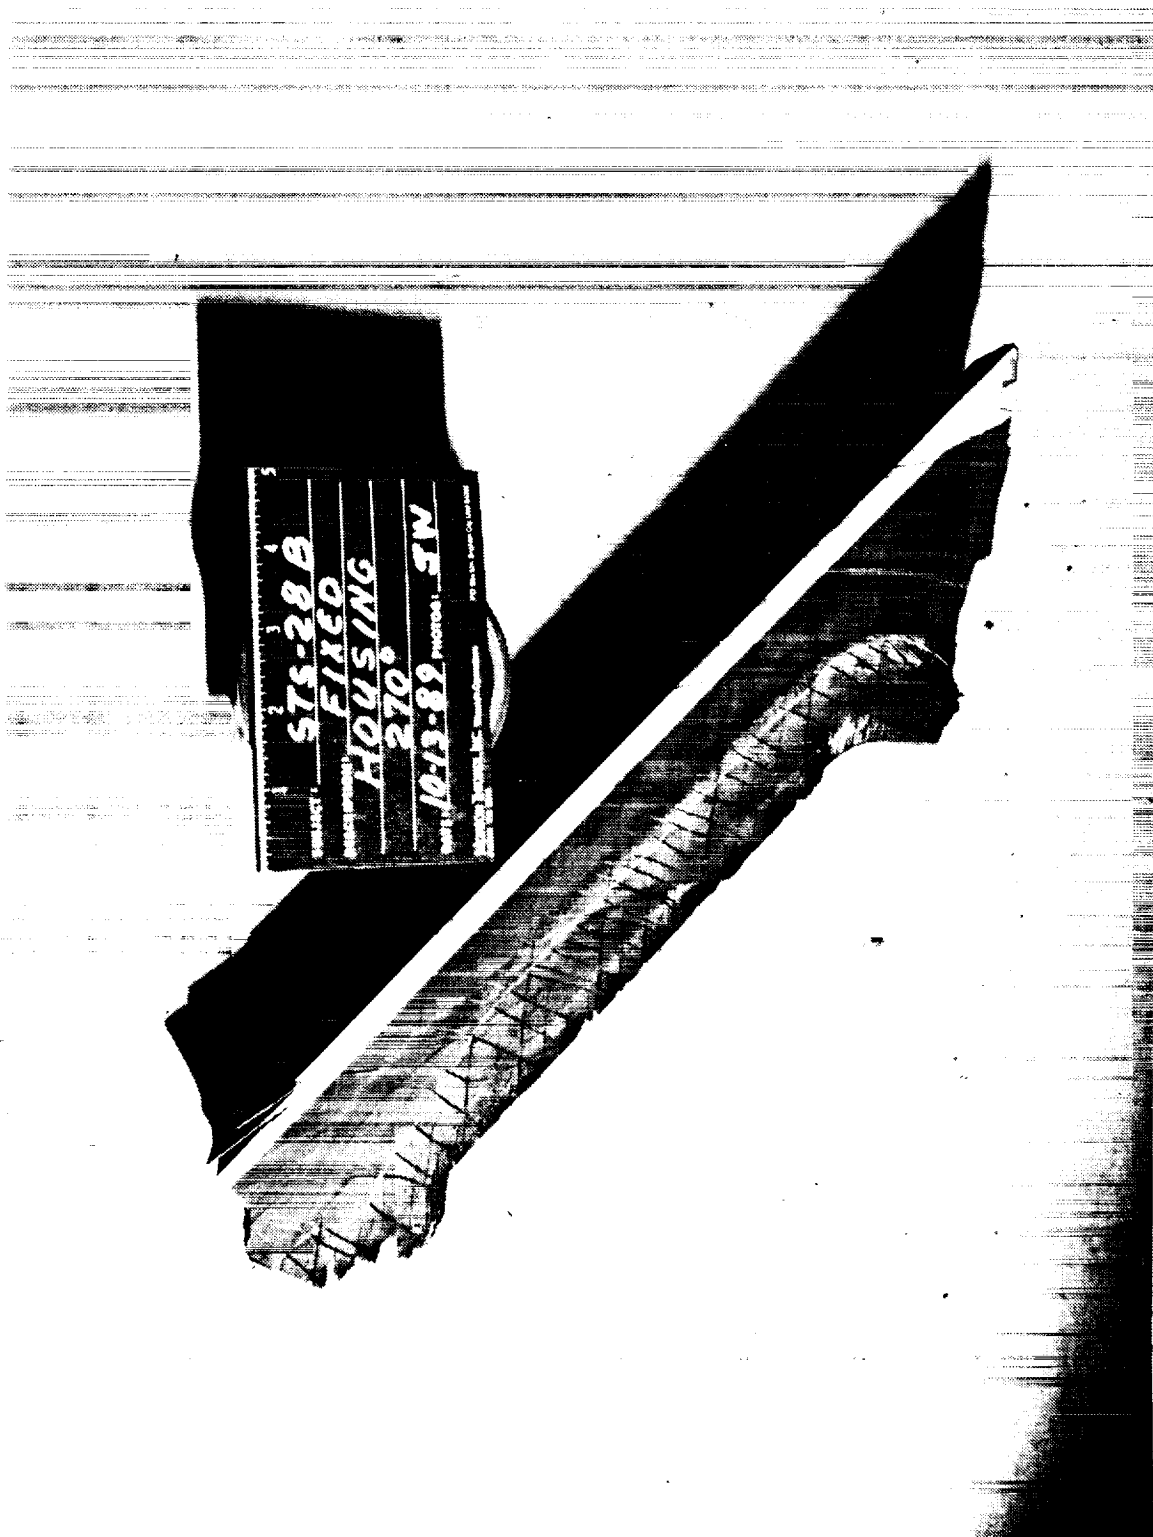
Photographs of the sectioned fixed housing assembly liner are presented in Figures 131 through 134. Char and erosion analysis of the sections is presented in Table 16. All margins of safety were positive, with a minimum of 0.27 occurring at station 10.75 (90 degrees).

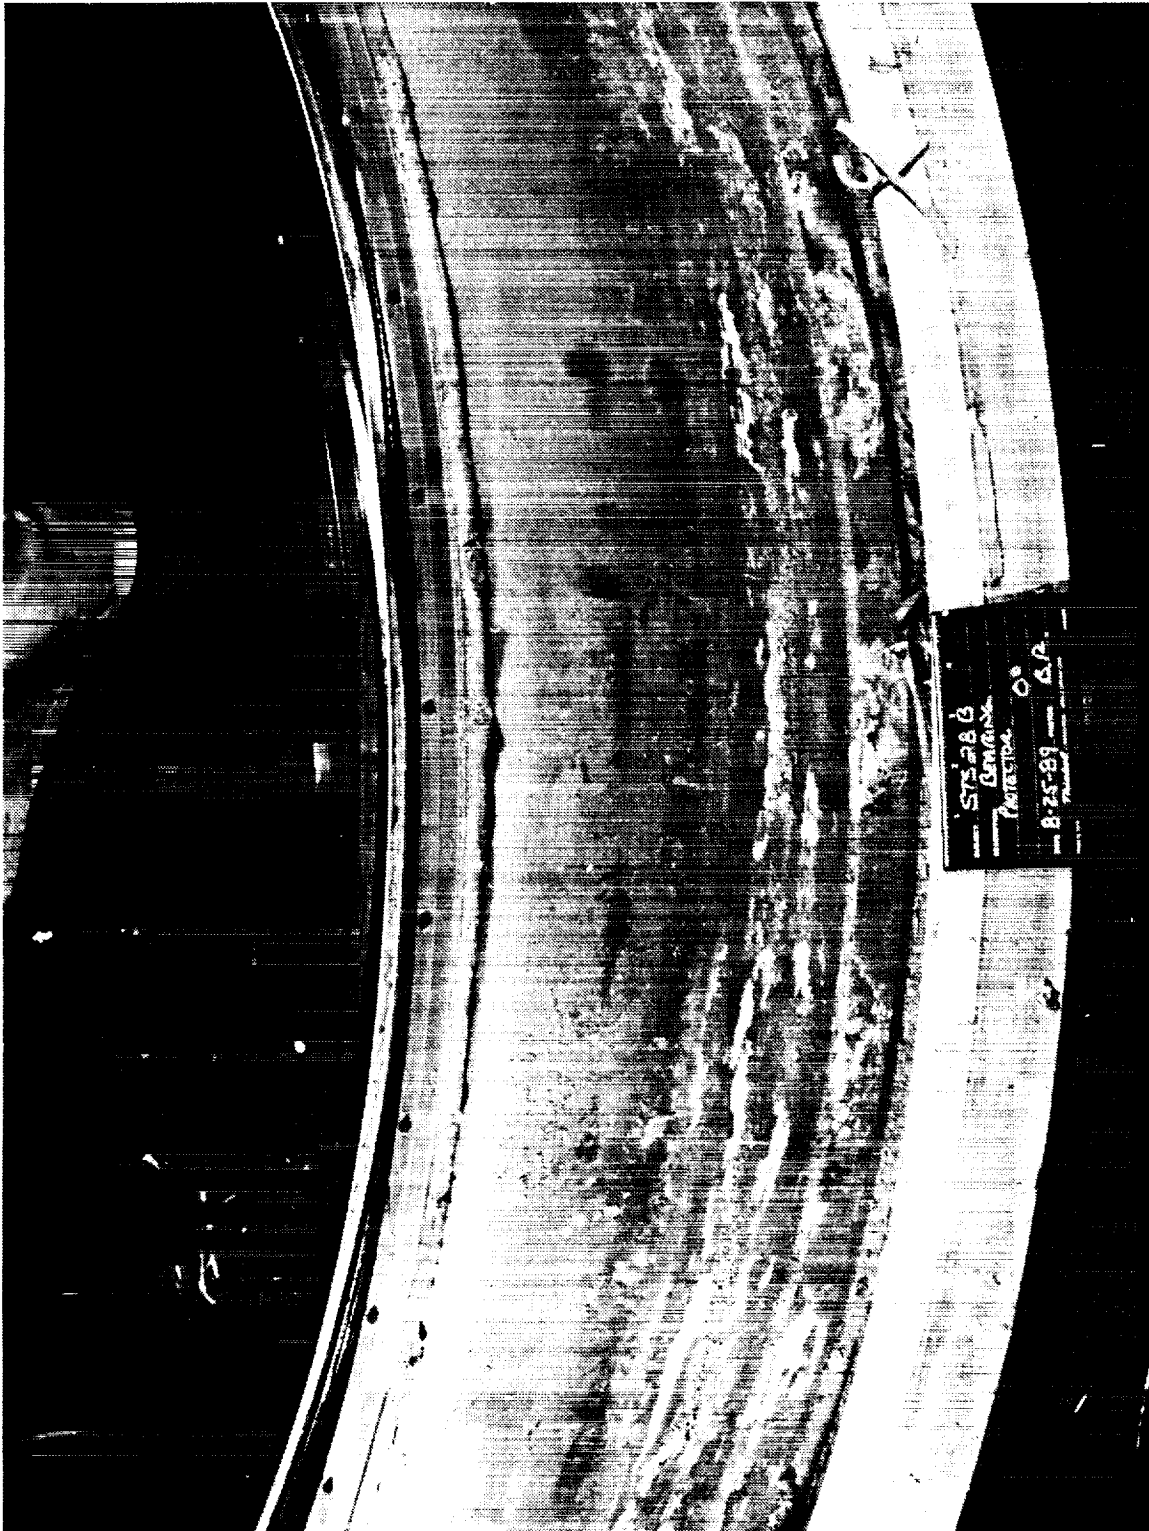
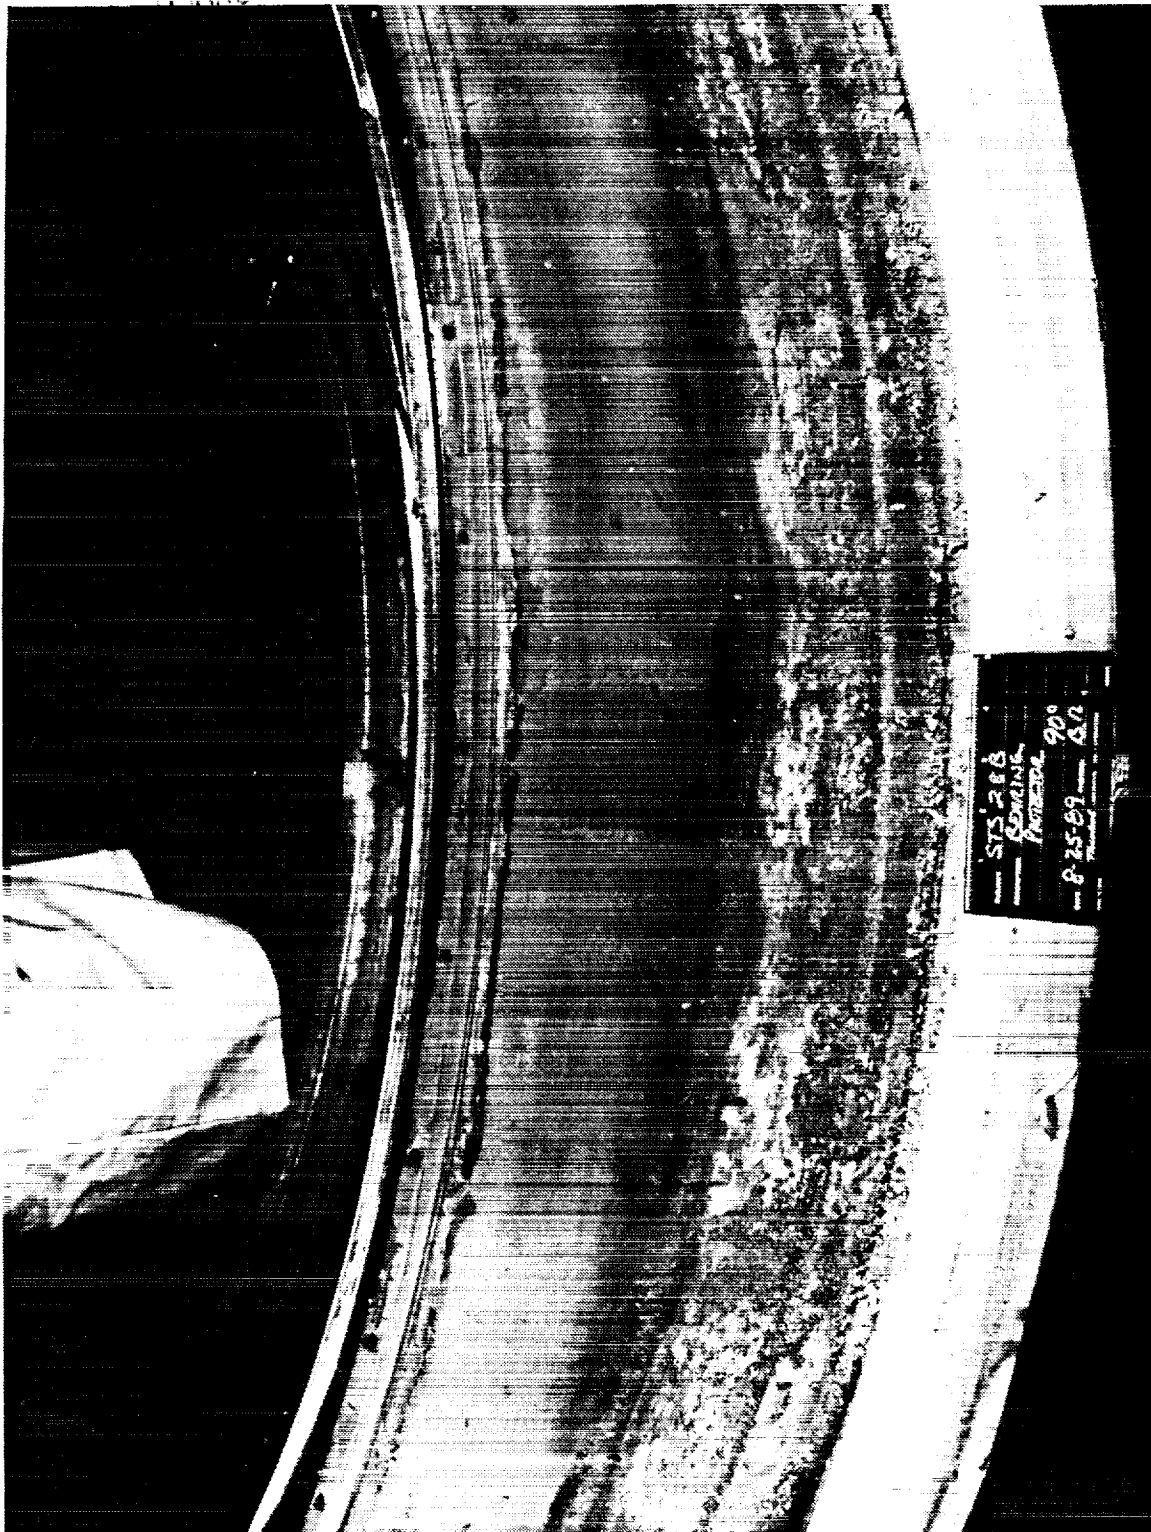
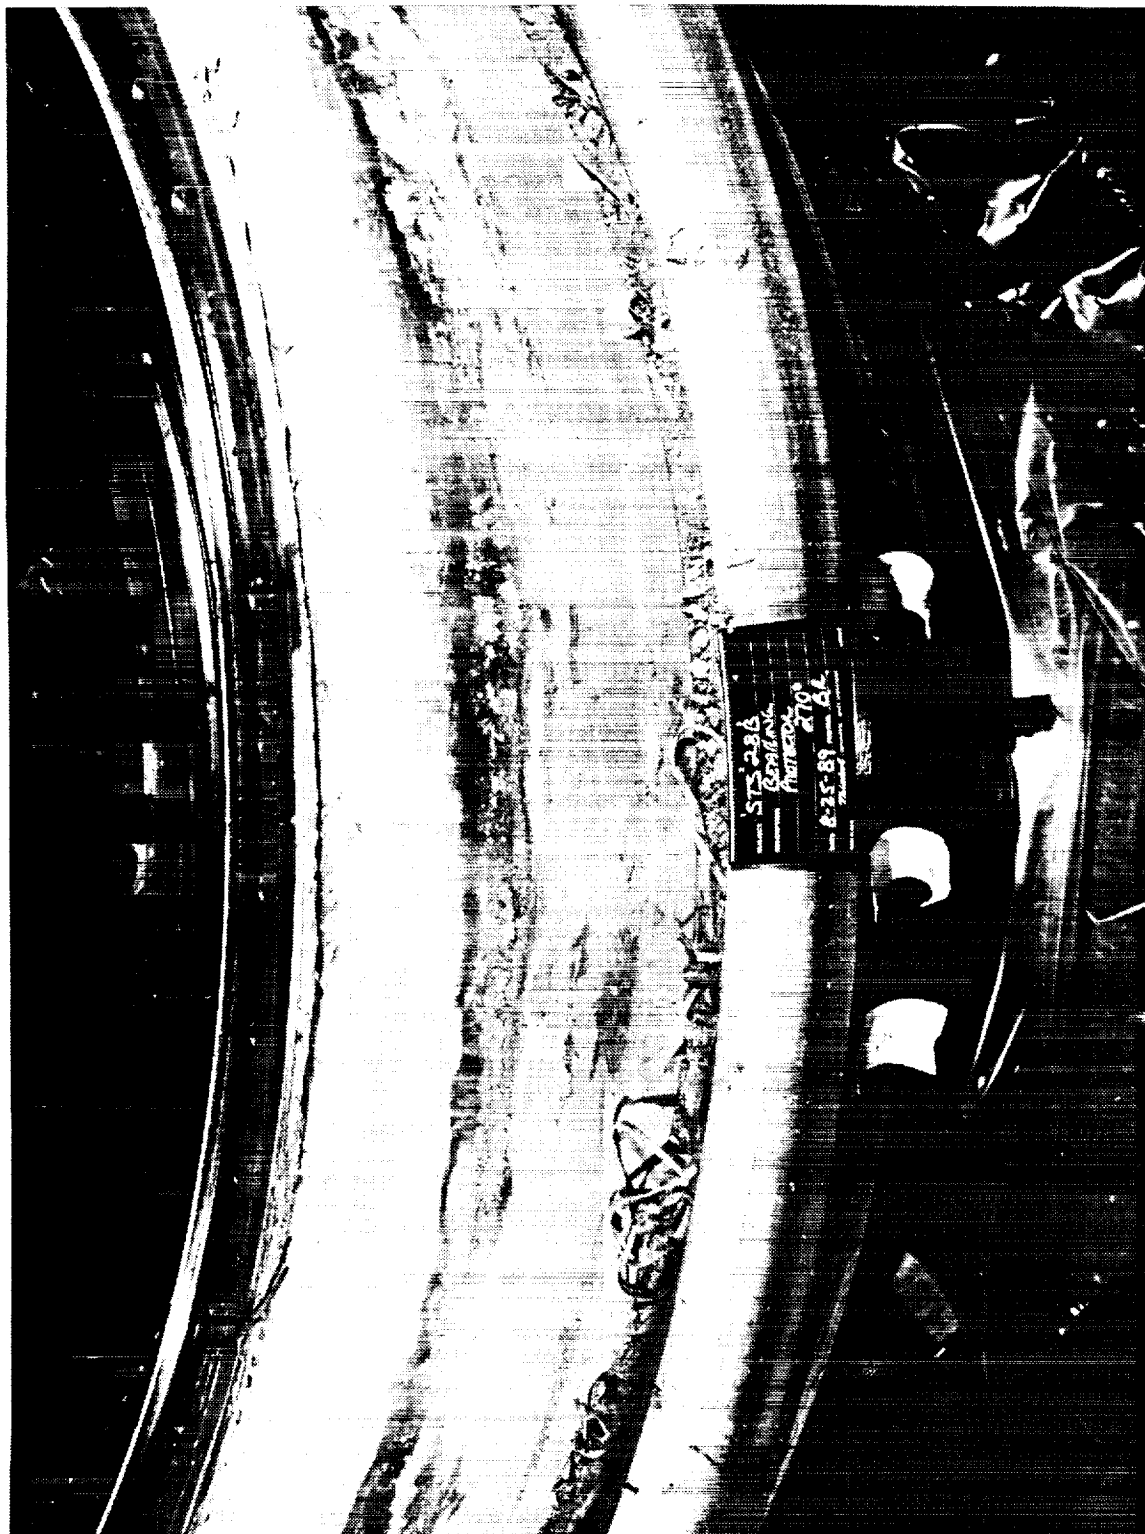
The bearing protector was sooted along the entire length and circumference (see Figures 135 through 137). Heavier soot and erosion were observed in line with the cowl ring vent holes at the thickened portion of the bearing protector. The greatest erosion was 0.06 inch at 40 degrees. There was no evidence of heat effect on the ID surface of the bearing protector.

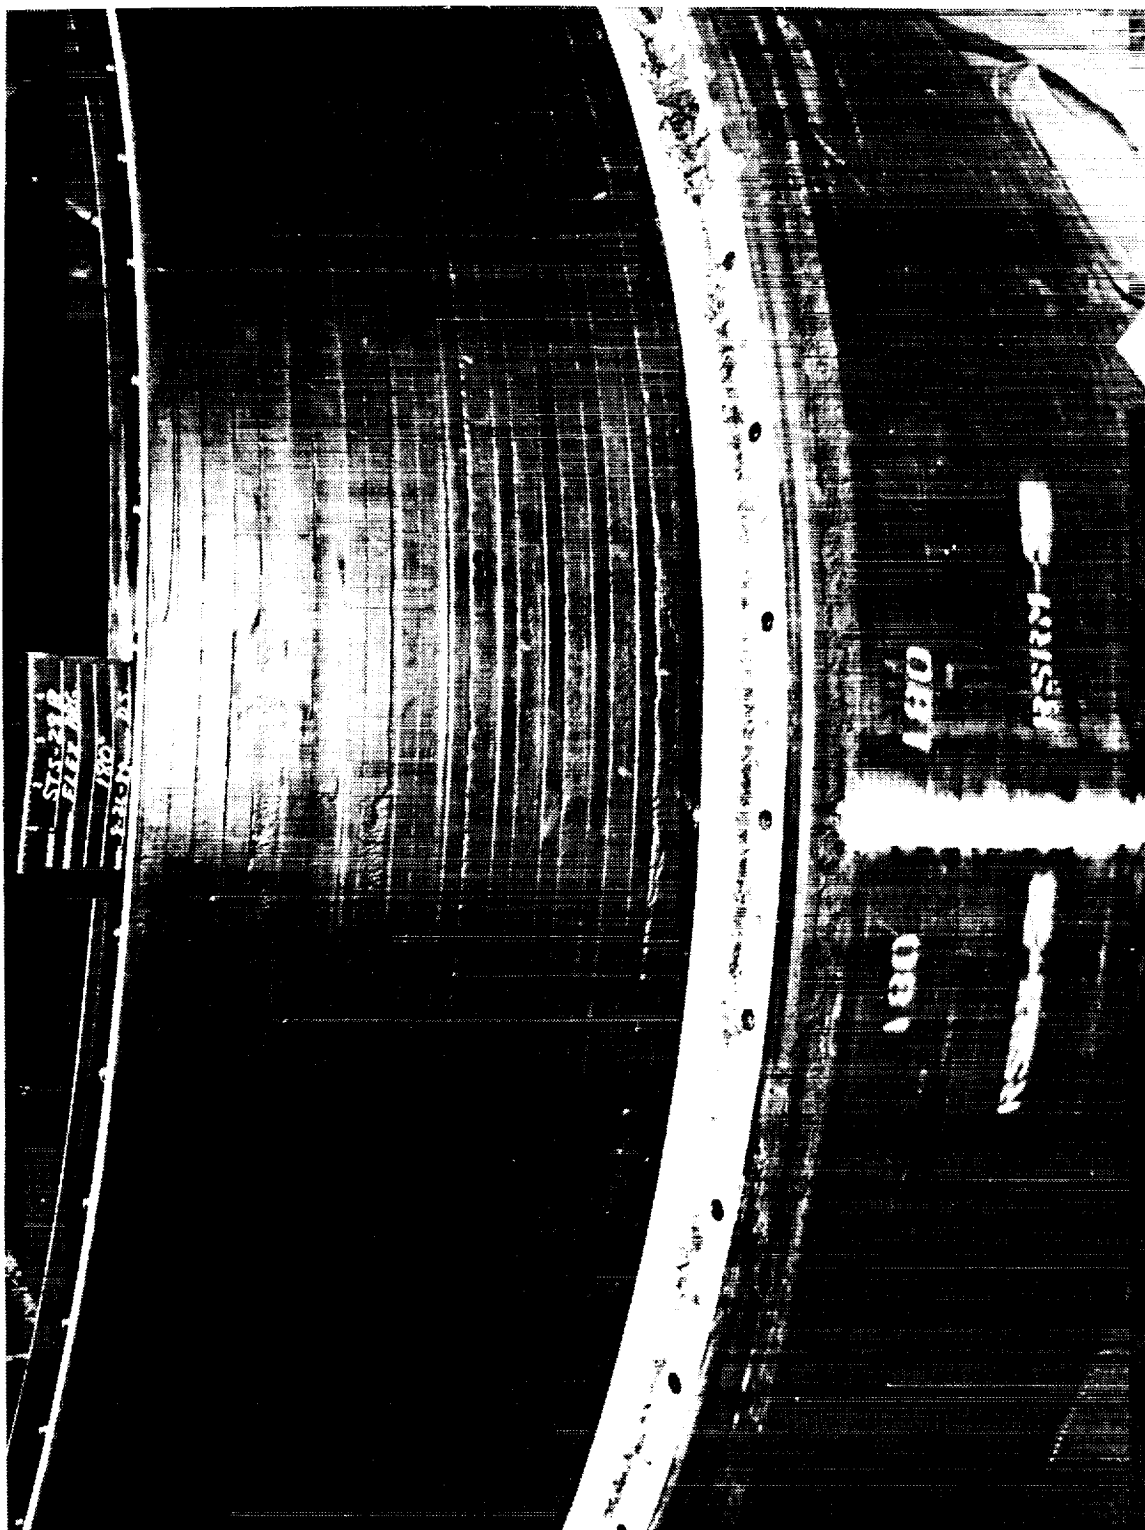
Figure 139 STS-28B Flex Bearing (180 deg)

Visual examination of the flex bearing revealed no damage, soot, heat effect, or flow indications (see Figures 138 and 139). All rubber pads, metal shims, and end rings appeared to be in nominal condition. Subsequent testing has shown an unacceptable unbond area. This was written up on DR 165119. Acceptance tests have not been completed.
